Manhole Inspection Summary

Manhole # S29CC2011MH

Insp Date: **10/2/08 10:41 AM**

Location Address: **4 TAMWORTH RD**

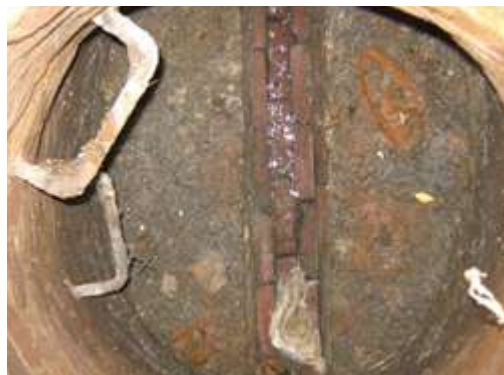
Top View

Corroded steps. Evidence of surcharge - Bench debris. Channel debris.

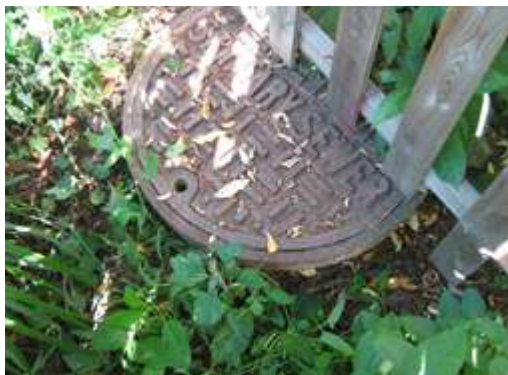
Under fence

Above grade.

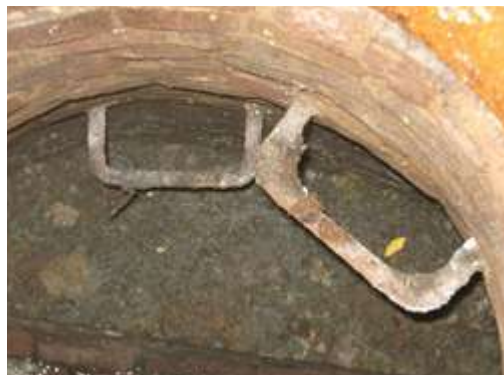
Defect

Frame leaks. Corbel deterioration and infiltration. Barrel infiltration - other side.

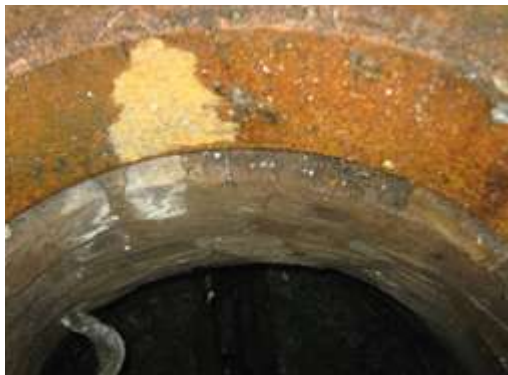
Defect

Frame leaks. Corbel deterioration and infiltration. Barrel infiltration.

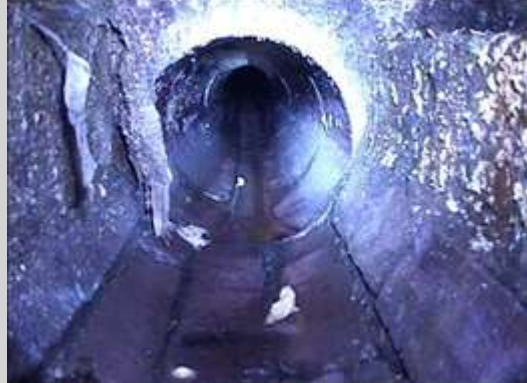
8 in. Circular Gravity Sewer Pipe Out @ 12 O'Clock

Deposits: ☒ None ☐ Mud ☐ Sludge ☐ Debris ☐ Grease

Infiltration: **None** Pipe Seal Cond: **Unknown**

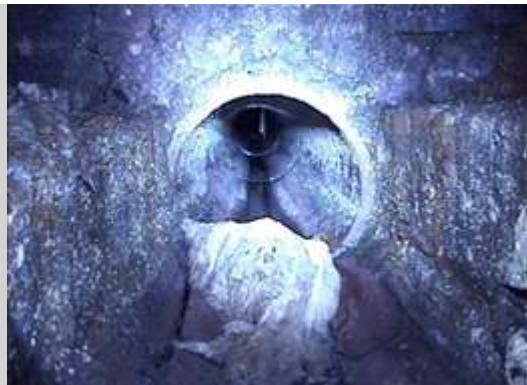
8 in. Circular Gravity Sewer Pipe In @ 6 O'Clock

Deposits: ☐ None ☐ Mud ☐ Sludge ☒ Debris ☒ Grease

Silt Depth: **0** (in.) Deposits Extent: **Light**

Infiltration: **None** Pipe Seal Cond: **Unknown**
